Manhole Inspection Summary

Manhole # S21UU1016MH

Inspection ☐ Is Incomplete Rating: **3) Fair**

Insp Date: **7/22/08 9:03 AM**

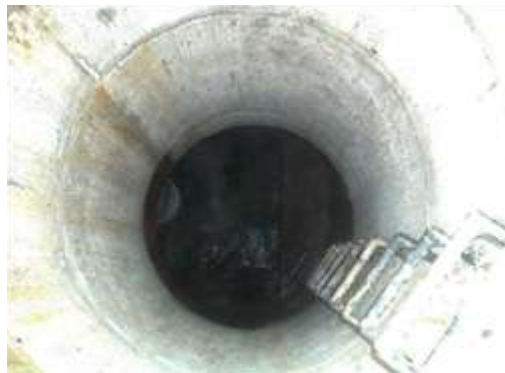
Top View

☐ Parged ☒ **Debris** (not Condition related)

Bench debris.

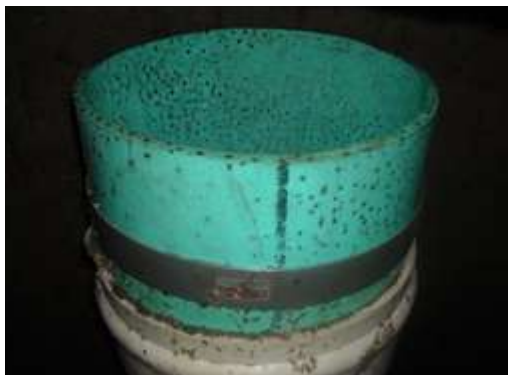
MISC.

PIPE EXTENSION TO 9 O'CLOCK DROP TEE

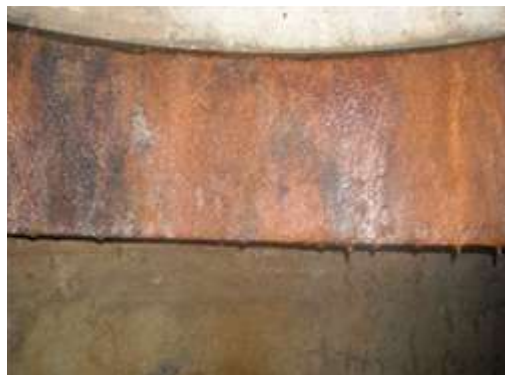
Defect

Infiltration: ☐ None ☒ **Joint** ☐ Cracks ☐ Mortar ☐ Roots ☐ Wall

Barrel infiltration.

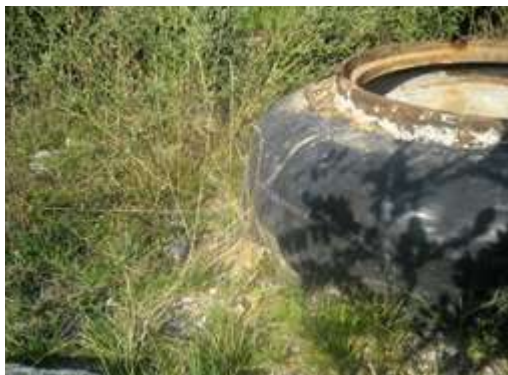
Defect

Diameter: **30** (in.) Length: (in.) Dist A/B Grade: **24** (in.)

Above grade.

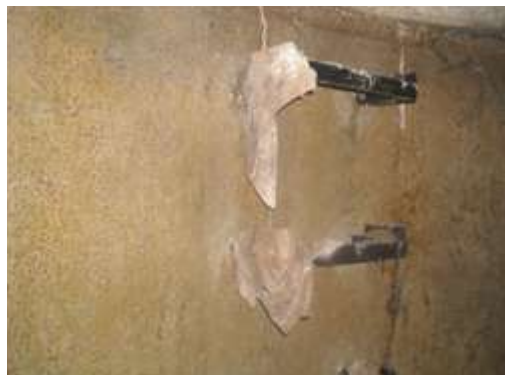
Defect

☒ **Evidence Of Surcharge**

Depth: **8** (ft.) ☐ Active Surcharge Present

Evidence of surcharge.

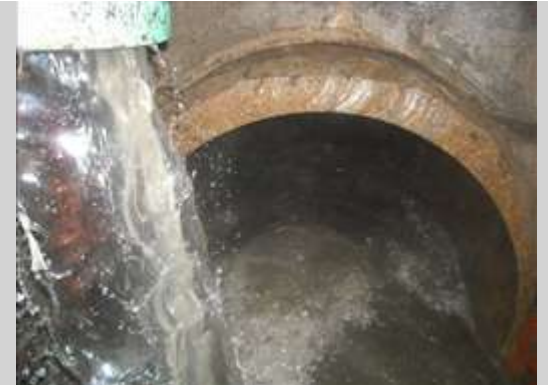
48 in. Circular Gravity Sewer Pipe Out @ 12 O'Clock

Infiltration: **Evidence** Pipe Seal Cond: **Sound**

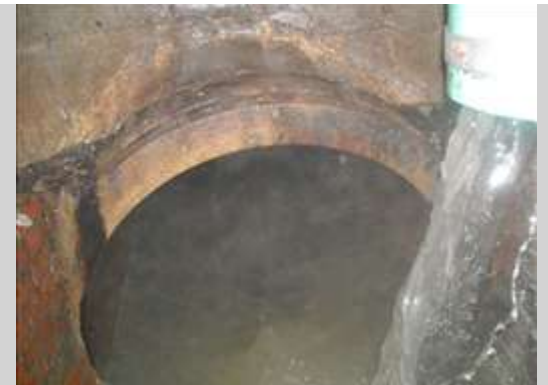
48 in. Circular Gravity Sewer Pipe In @ 6 O'Clock

Infiltration: **Evidence** Pipe Seal Cond: **Sound**

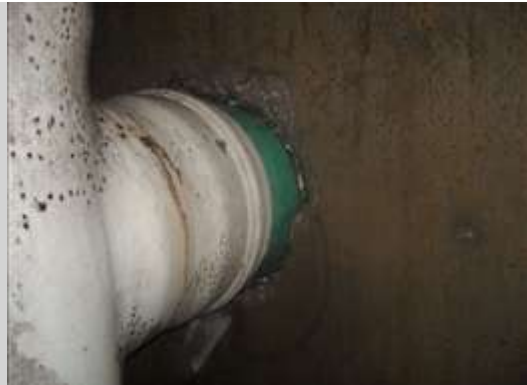
Pipe In @ 9 O'Clock

Infiltration: **Evidence**
